Navajo Abandoned Uranium Mine Site Screen Report

Williams and Reynolds AUM Site

Navajo AUM Eastern Region

Weston Solutions, Inc.

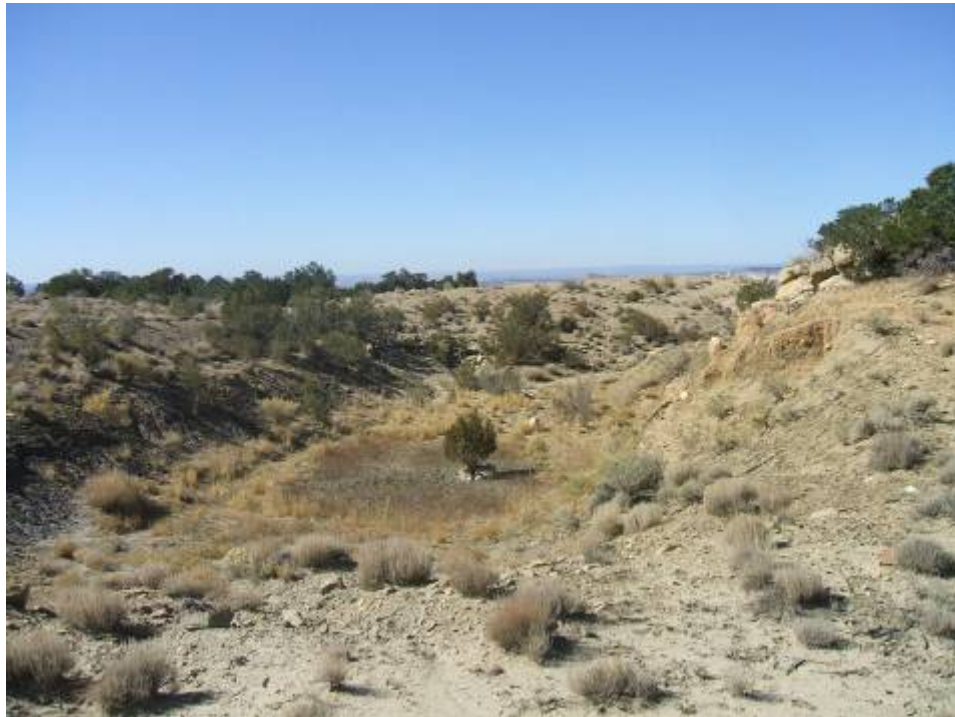
Reclamation status of the mine site is currently unknown. A recessed area was observed in the center of the site. No waste piles, adits or other mine features were observed during the site visit.

Photo 1. Mine site and recessed area, towards the northwest

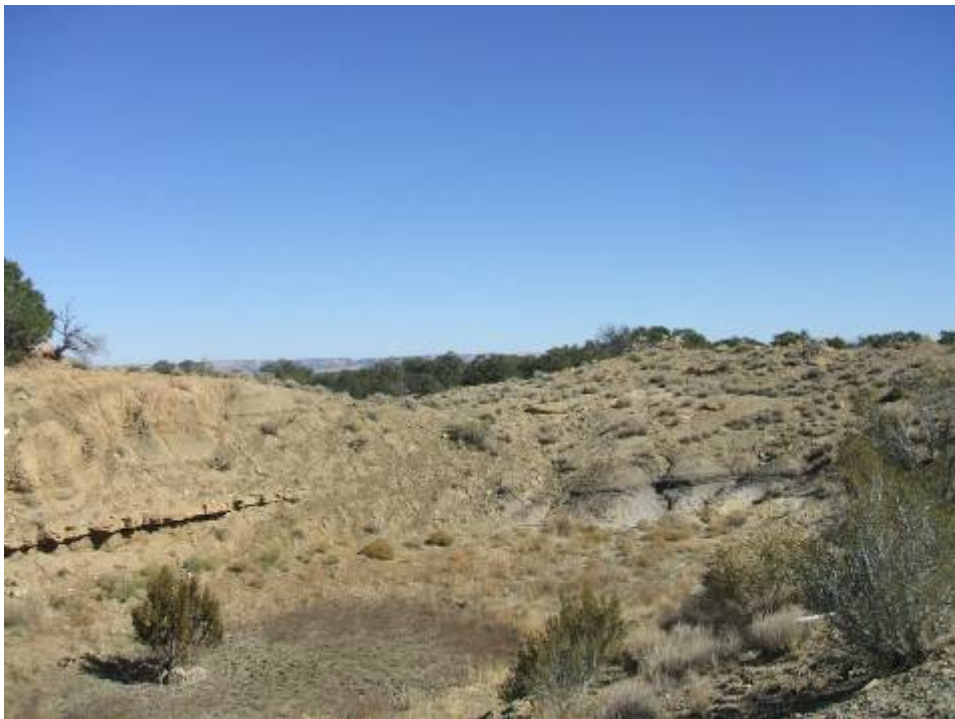
Photo 2. Mine site and recessed area, towards the southeast

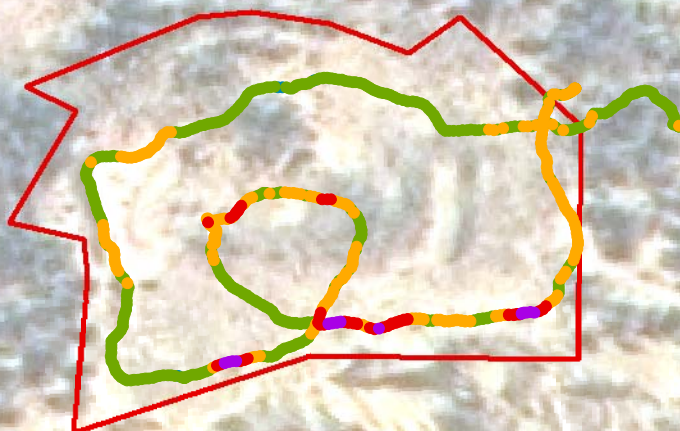
Figure 2

A total of 582 gamma radiation measurements were collected from mine sites, ranging from 9,438 cpm to 72,420 cpm. The measurements are represented in Figures 1 and 2.

Gamma survey conducted in October 2008
measured as counts per minute

Gamma Radiation Measurements
Williams and Reynolds
Inyabito Chapter
Navajo Nation, New Mexico
